BROWNFIELD REDEVELOPMENT ASSESSMENT REPORT

PACKARD PLANT COMPLEX

DETROIT, MICHIGAN

March 24, 1998

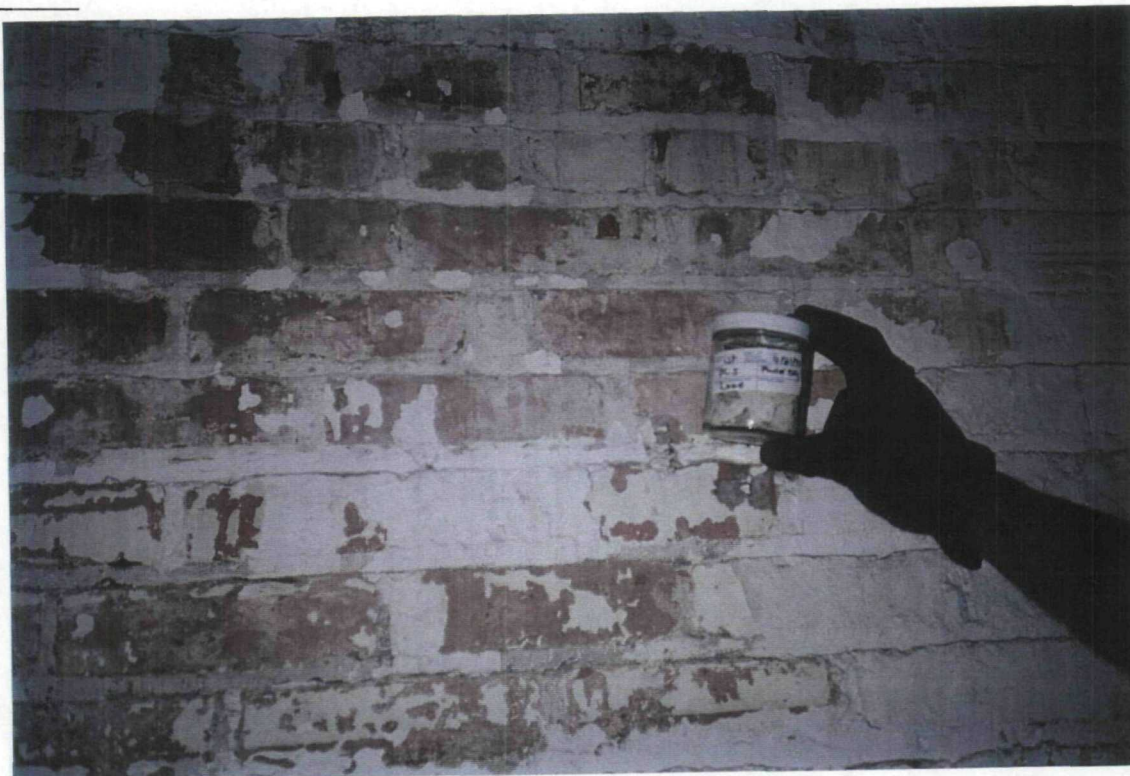
SAMPLE ID:  
PC 5

Paint Chip Sample 5 collected from the interior north wall on first floor of Building 9-8-7.
